TECHNICAL REPORT NO. LWL-CR-06C66A

AIRCRAFT MOUNTED PERSONNEL DETECTOR CHEMICAL

Final Phase IV Report
Contract No. DA-18-001-AMC-983(X)

By
Ordnance Systems
General Electric Company
Pittsfield, Massachusetts 01201

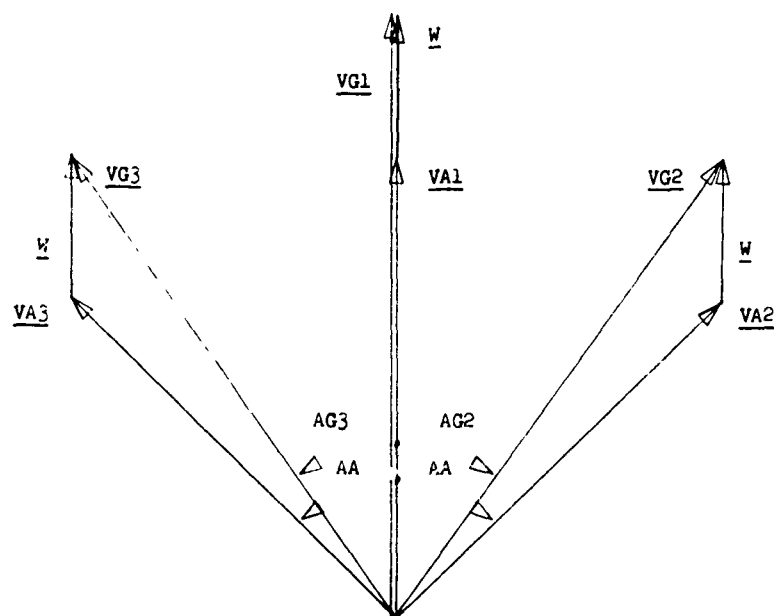
\underline{VA} - True Airspeed Vector
 \underline{AA} - True Airspeed Angular Spacing
 \underline{W} - Wind Vector
 \underline{VG} - Groundspeed Vector
 \underline{AG} - Ground Track Angle

Figure 3-61. Course Class 1 Vector Diagram.

3. 10. 6. 3. 1 Class I—Central True Airspeed Vector Along Wind Vector. The geometrical relationships for this class of courses is shown as figure 3-61. The true airspeed vector has an angle of either 0 or 180 degrees with the wind vector. Due to the symmetry of the situation errors of equal magnitude are produced by errors in groundspeeds VG2 and VG3 by errors in ground track angles AG2 and AG3, and by errors in true airspeed variations ΔVA_2 and ΔVA_3 . Therefore a single plot is used for each set.

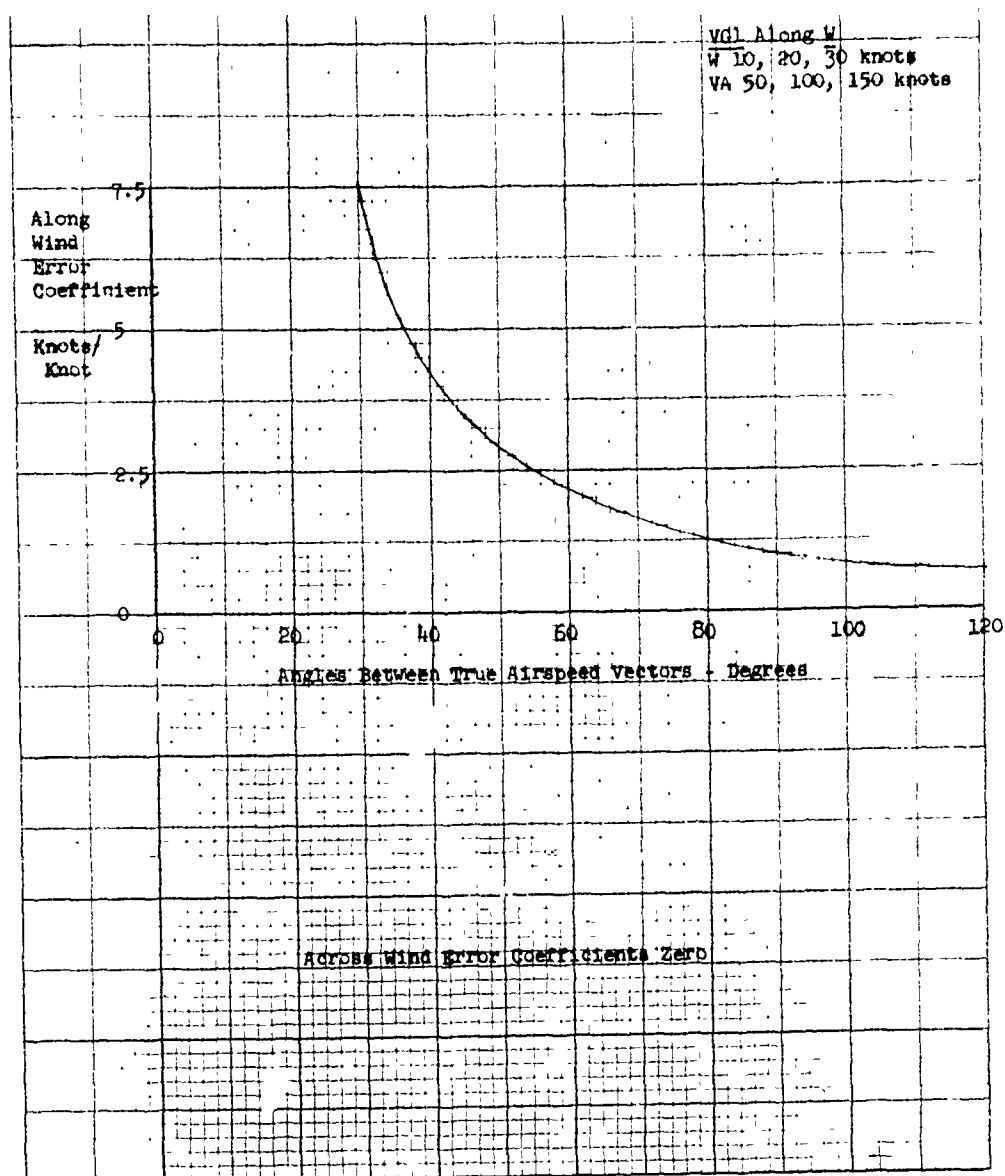
Figure 3-62. Error Coefficients for Error in VG1 Magnitude.

The error coefficients for groundspeed VG1 are presented on figure 3-62, while that for groundspeeds VG2 and VG3 are plotted in figure 3-63. The error coefficients for ground track angle AG1 are plotted in figure 3-64, with those for ground track angles AG2 and AG3 plotted in figure 3-65. Figure 3-66 shows the error coefficients for true airspeed variations ΔVA_2 and ΔVA_3 .

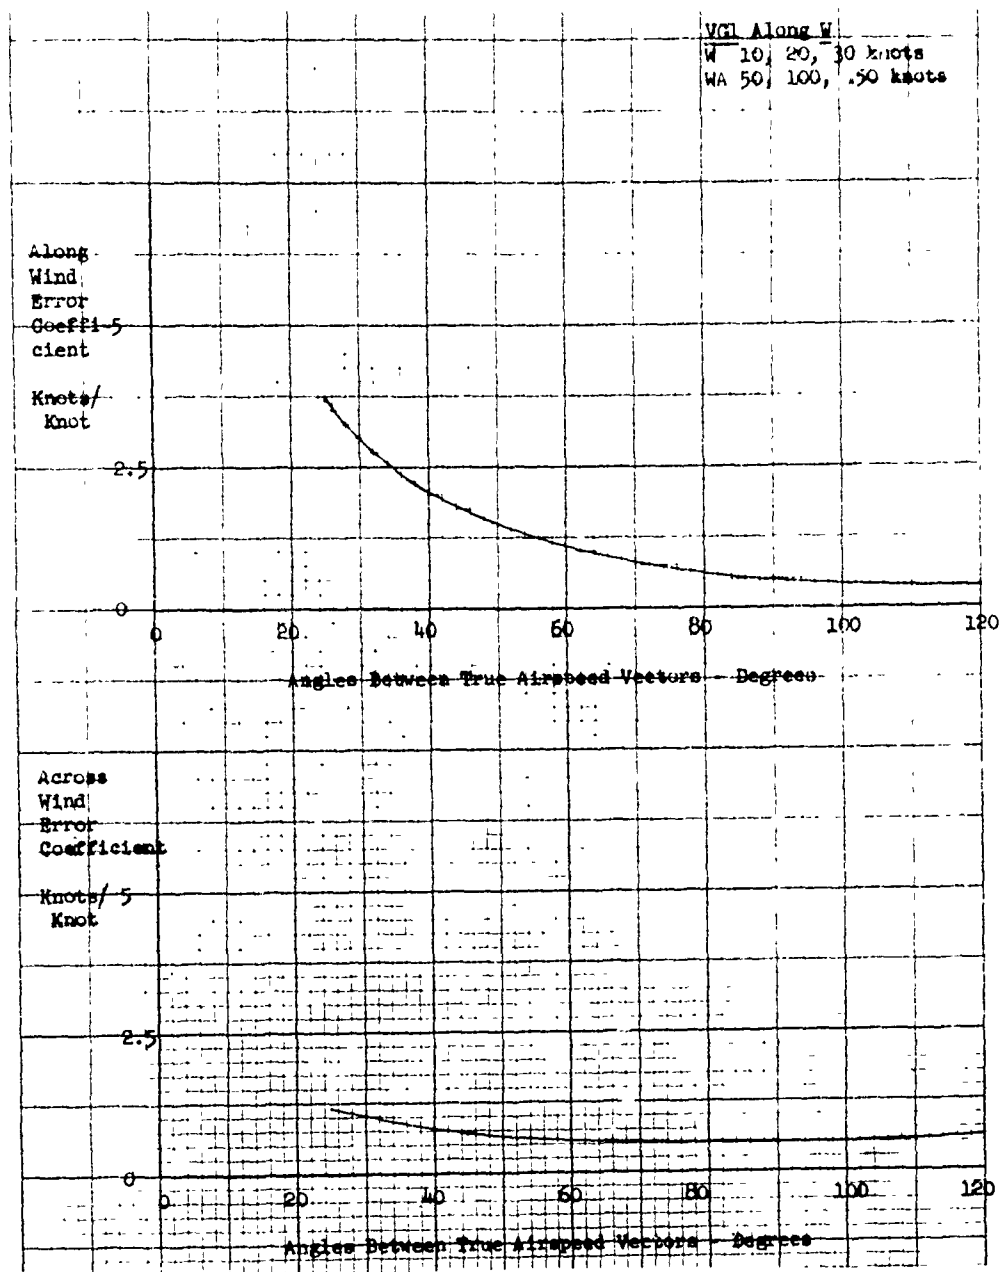
Figure 3-63. Error Coefficients for Error in VG2 or VG3 Magnitudes.

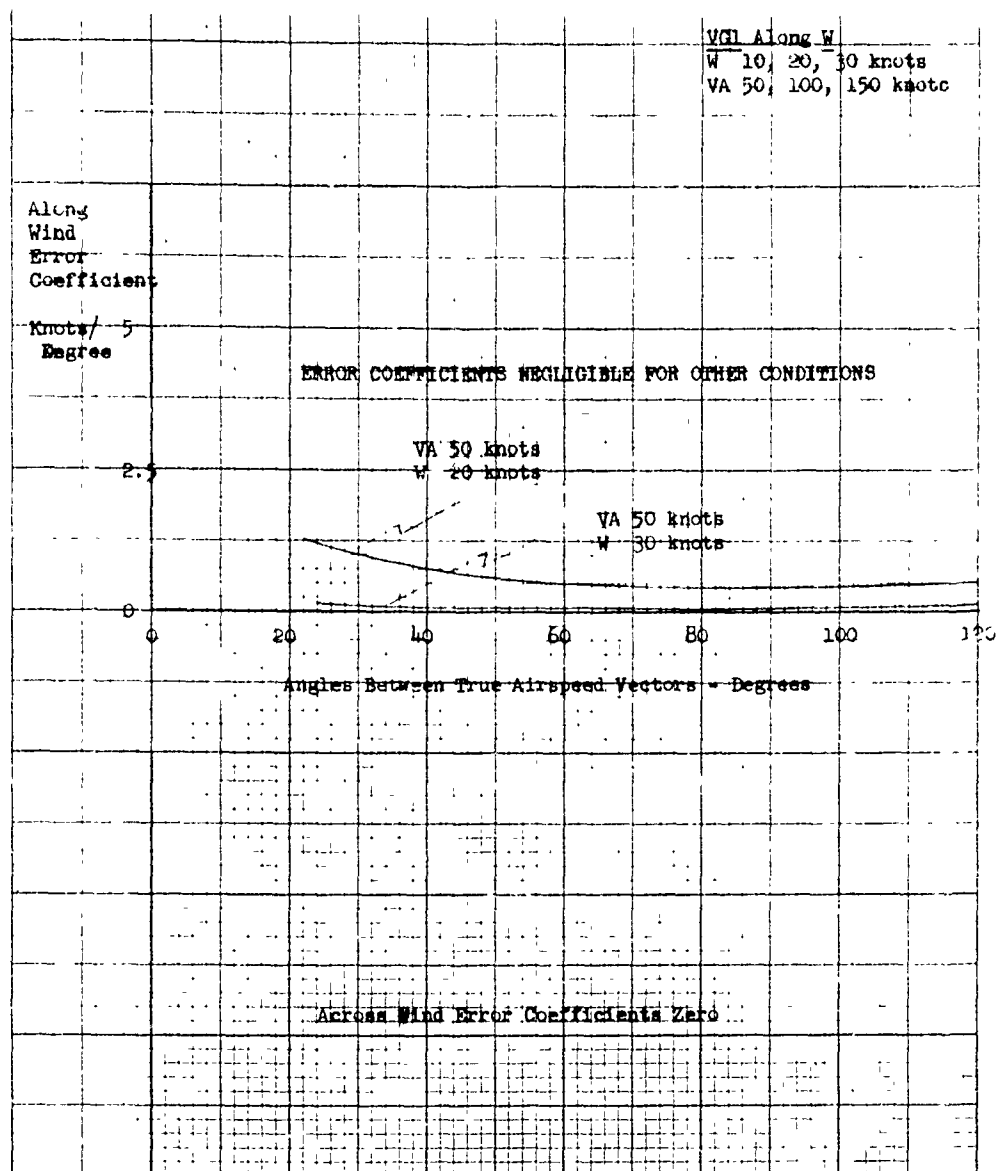
Figure 3-64. Error Coefficients for Error in Ground Track Angle AG1.

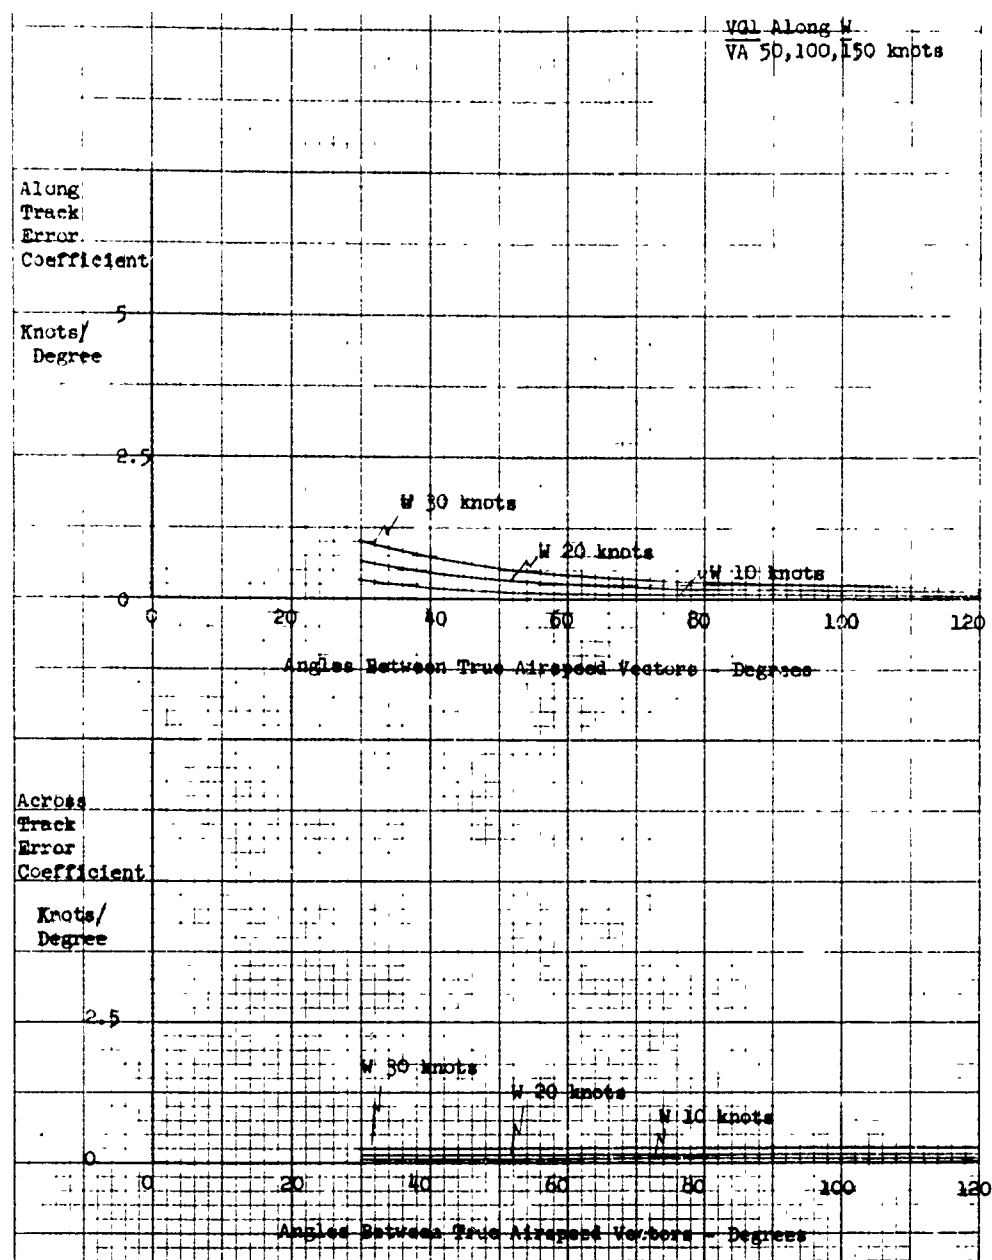
Figure 3-65. Error Coefficients for Error in Ground Track Angles AG2 or AG3.

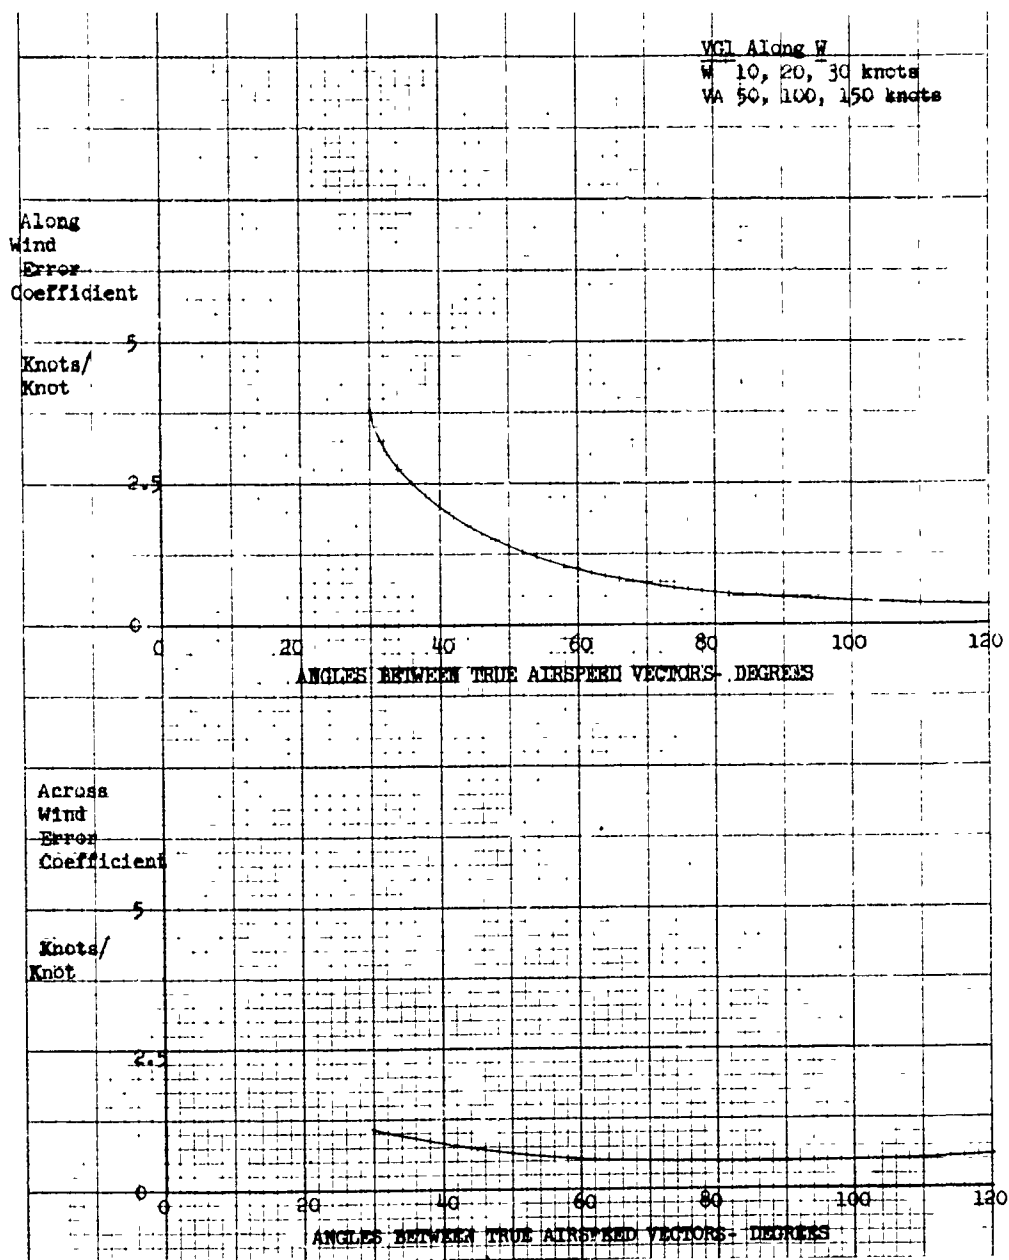
Figure 3-66. Error Coefficients for Error in $\Delta VA2$ or $\Delta VA3$ Magnitudes.

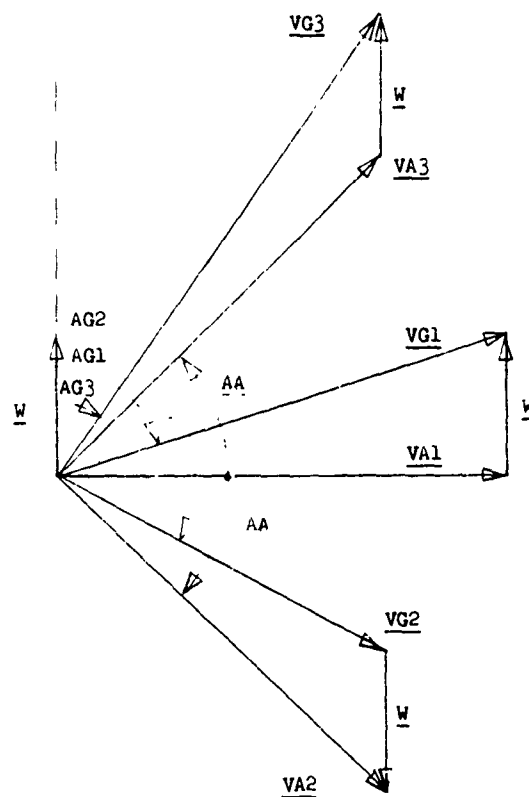
\underline{VA} - True Airspeed Vector
 \underline{AA} - True Airspeed Angular Spacing
 \underline{W} - Wind Vector
 \underline{VG} - Groundspeed Vector
 \underline{AG} - Ground Track Angle

Figure 3-67. Course Class 2 Vector Diagram.

3. 10. 6. 3. 2 Class II—Central True Airspeed Vector Perpendicular to Wind Vector. The geometrical relationships for this class of courses are shown as figure 3-67. Examination of the data showed that the error coefficients for VG2 and VG3, AG2 and AG3, and ΔVA_2 and ΔVA_3 were very nearly the same. Therefore, single plots have been made for each of these sets of conditions.

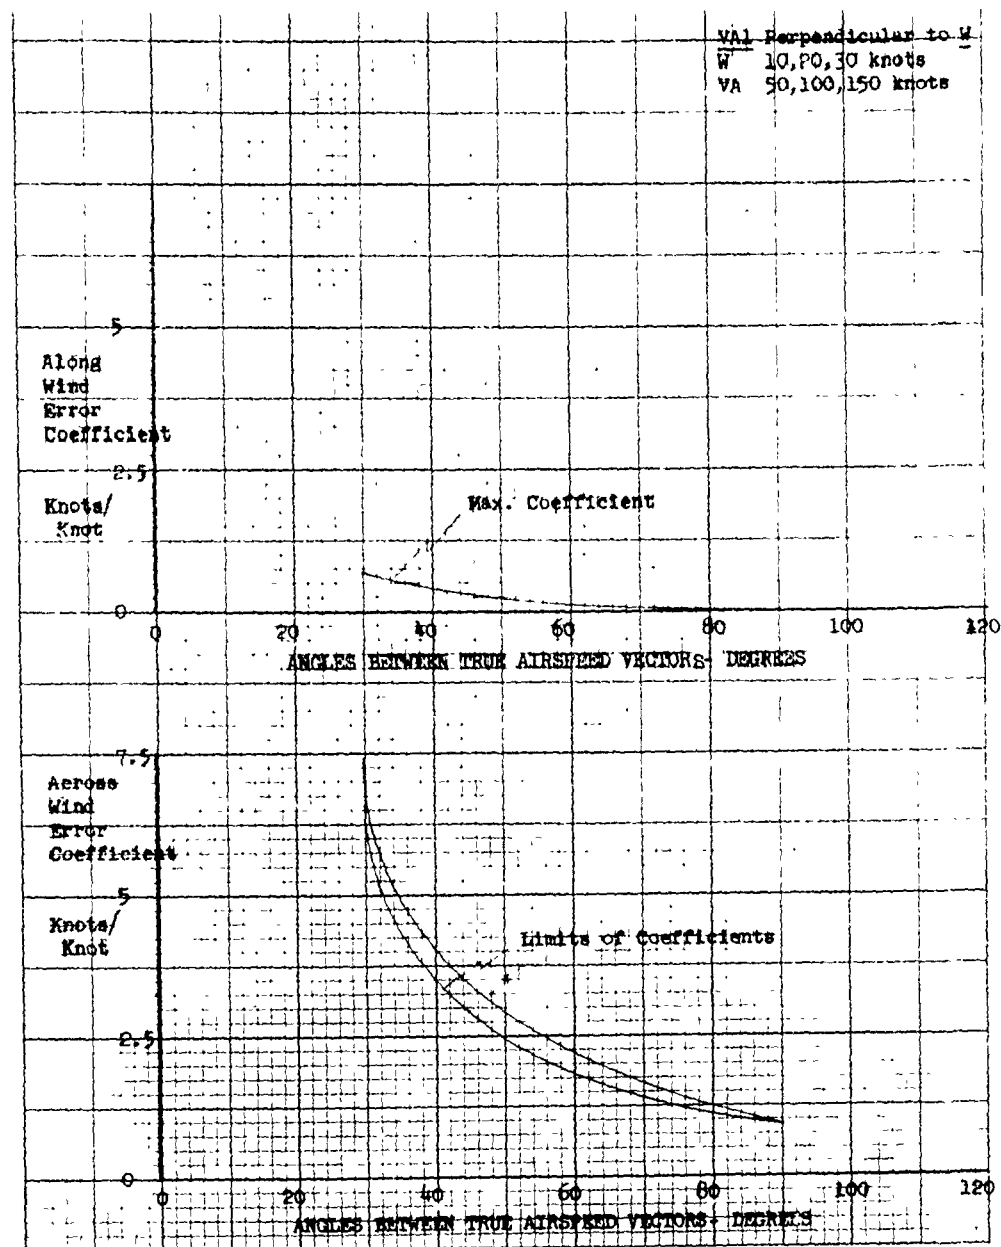
Figure 3-68. Error Coefficients for Error in VG1 Magnitude.

The data for groundspeed VG1 is plotted in figure 3-68, with that for groundspeeds VG2 and VG3 plotted in figure 3-69. Figure 3-70 shows the error coefficients for ground track angle AG1 while figure 3-71 shows those for ground track angles AG2 and AG3. The error coefficients for true airspeed variations ΔVG_2 and ΔVG_3 are presented in figure 3-72.

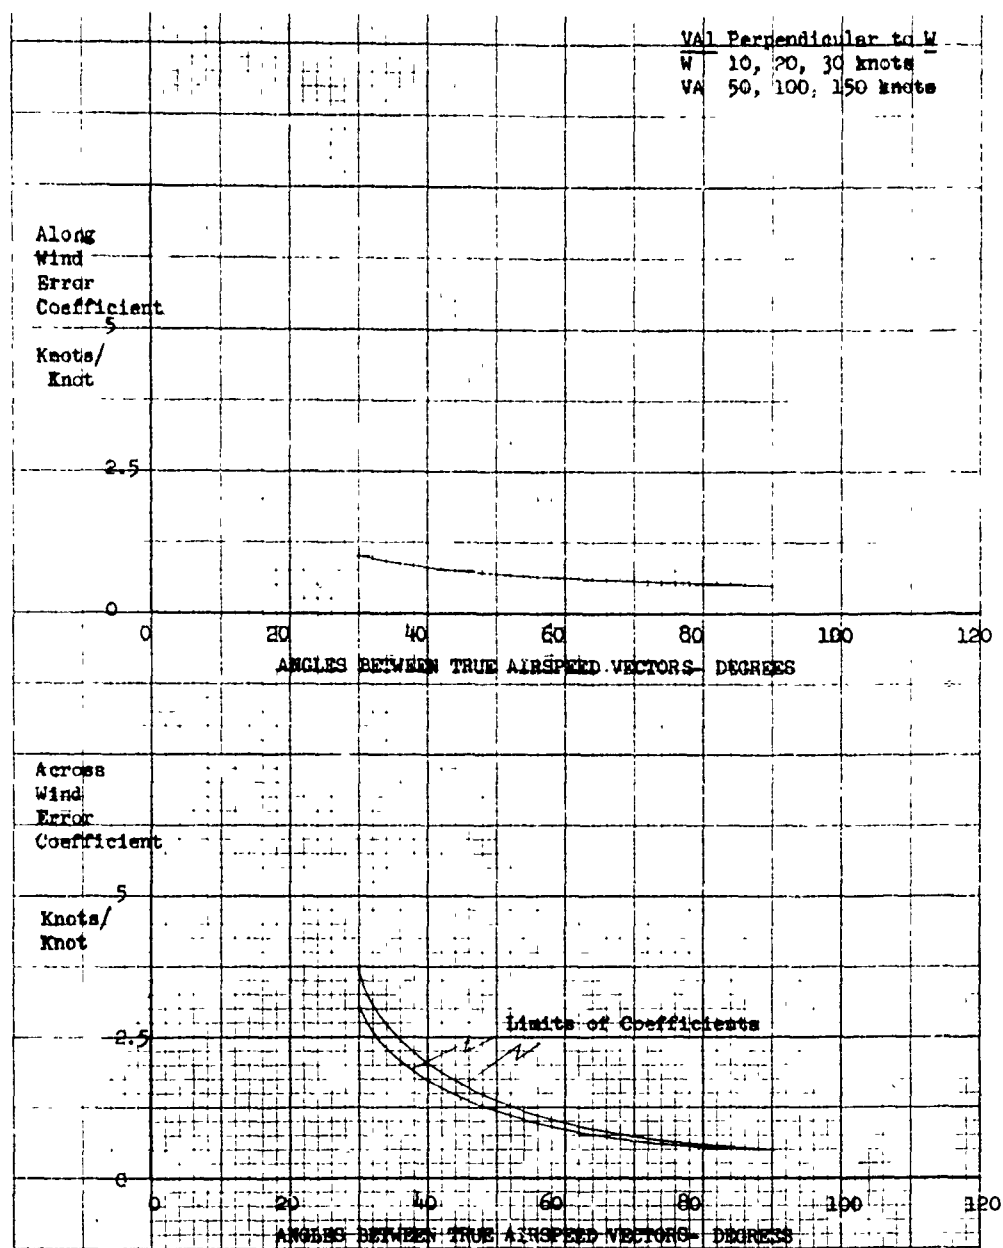
Figure 3-69. Error Coefficients for Error in VG2 and VG3 Magnitudes.

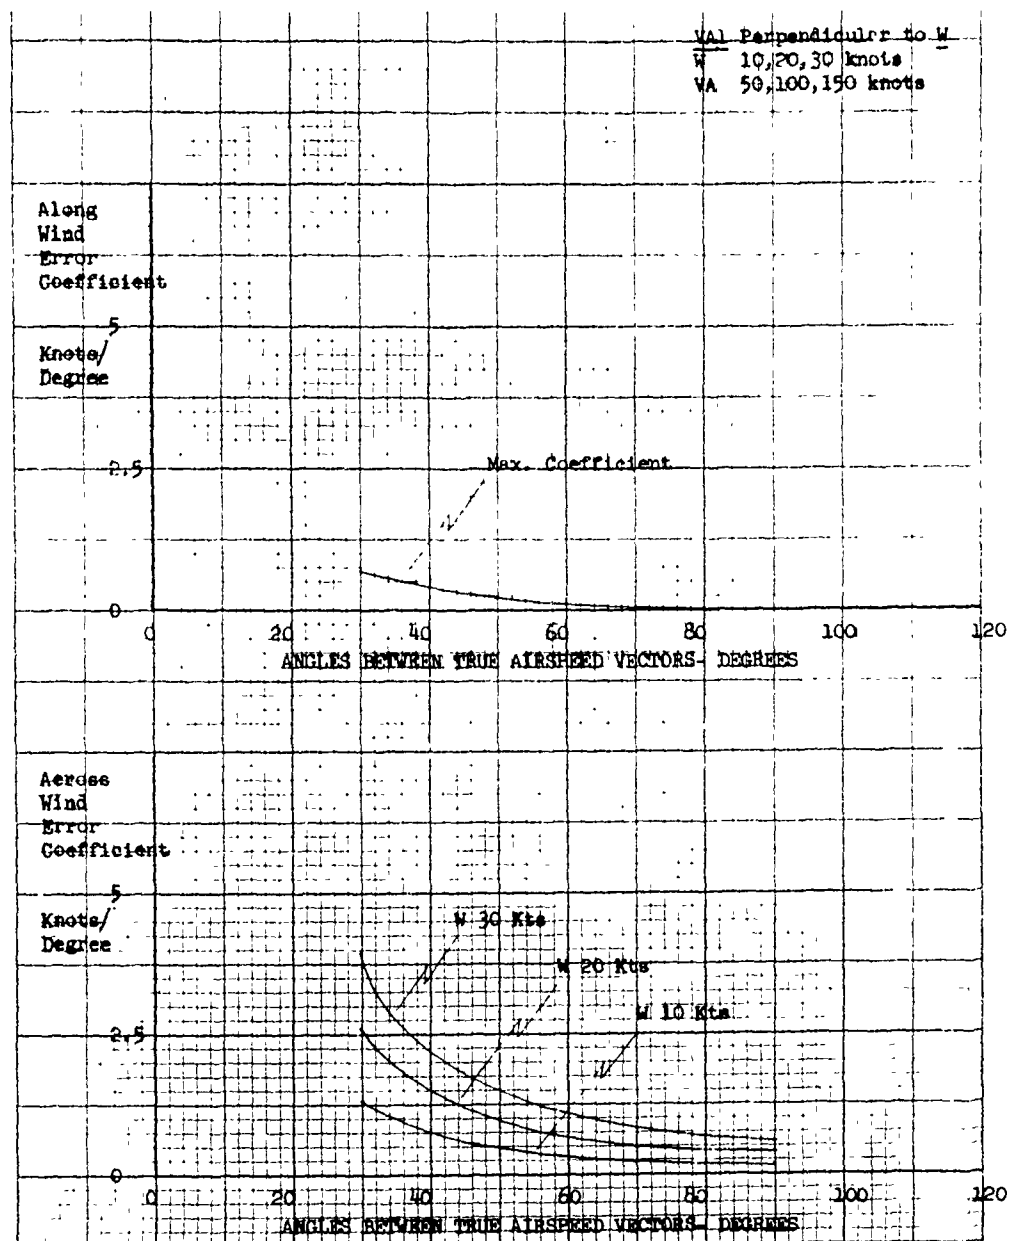
Figure 3-70. Coefficients for Error in Ground Track Angle AG1.

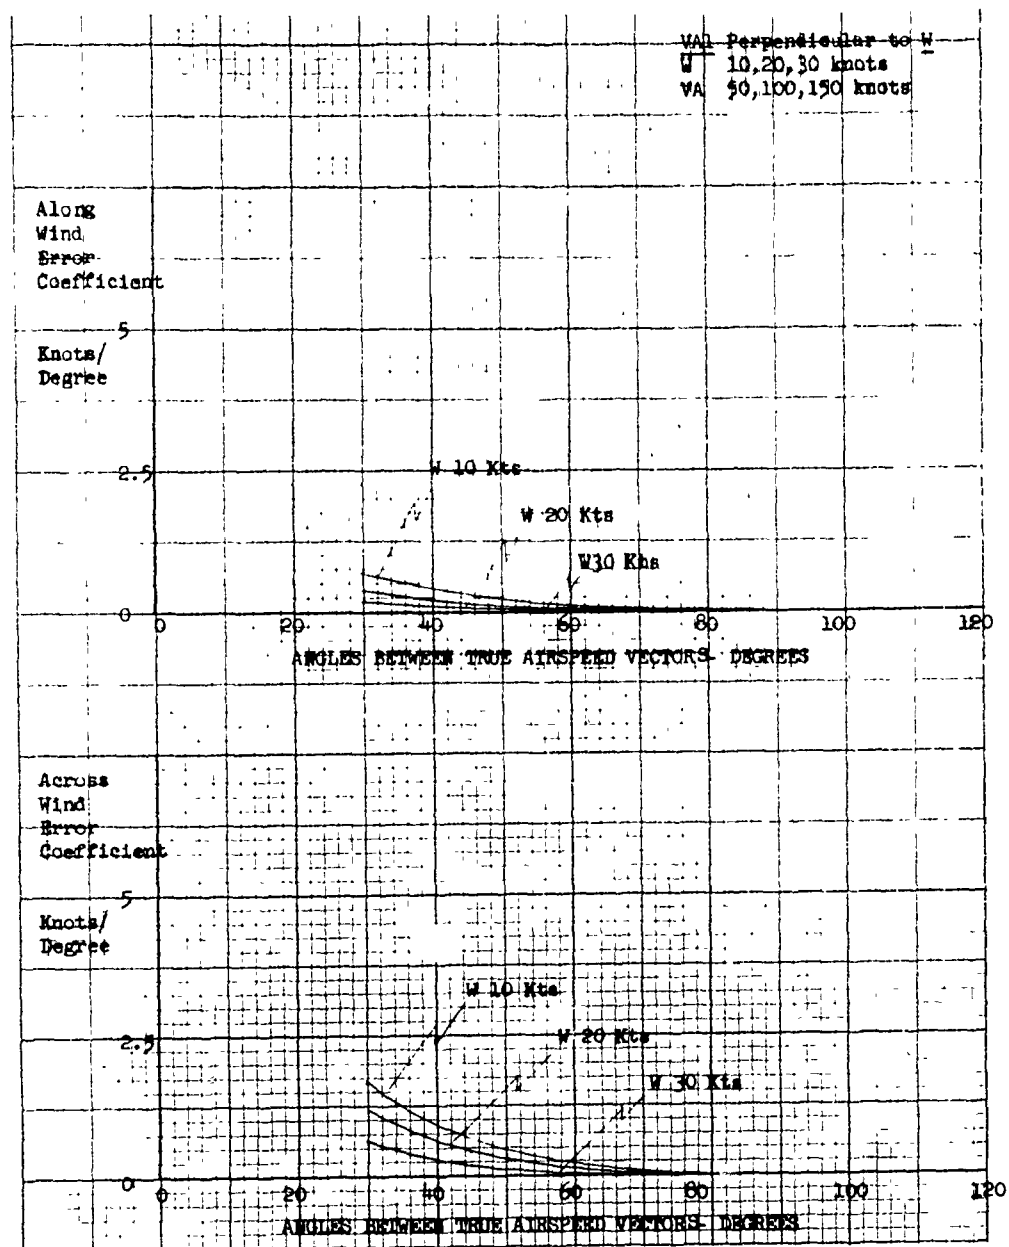
Figure 3-71. Coefficients for Error for Ground Track Angies AG2 and AG3.

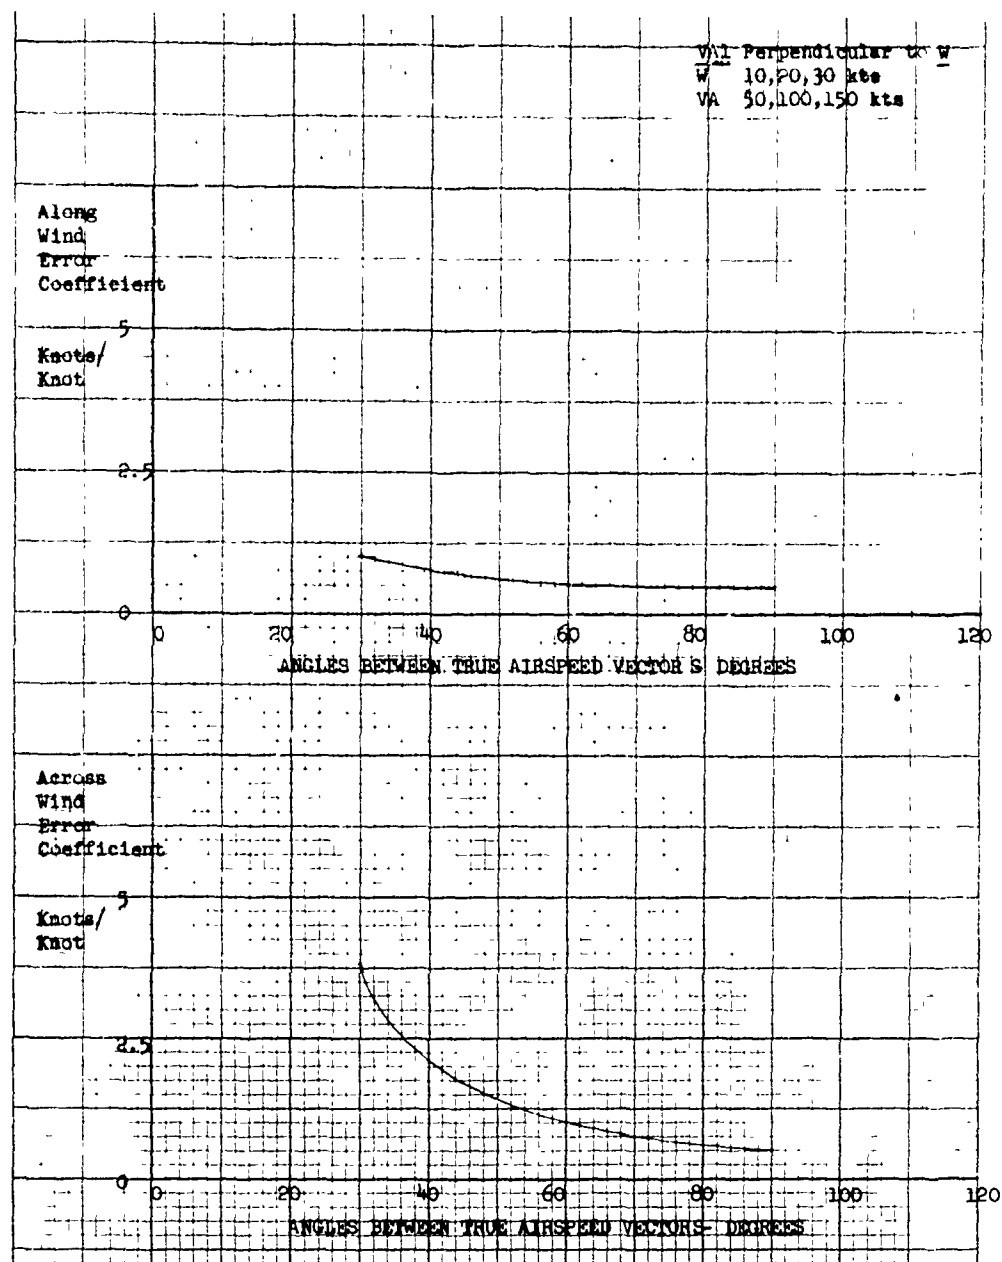
Figure 3-72. Coefficients for Error in $\Delta VA2$ or $\Delta VA3$ Magnitudes.

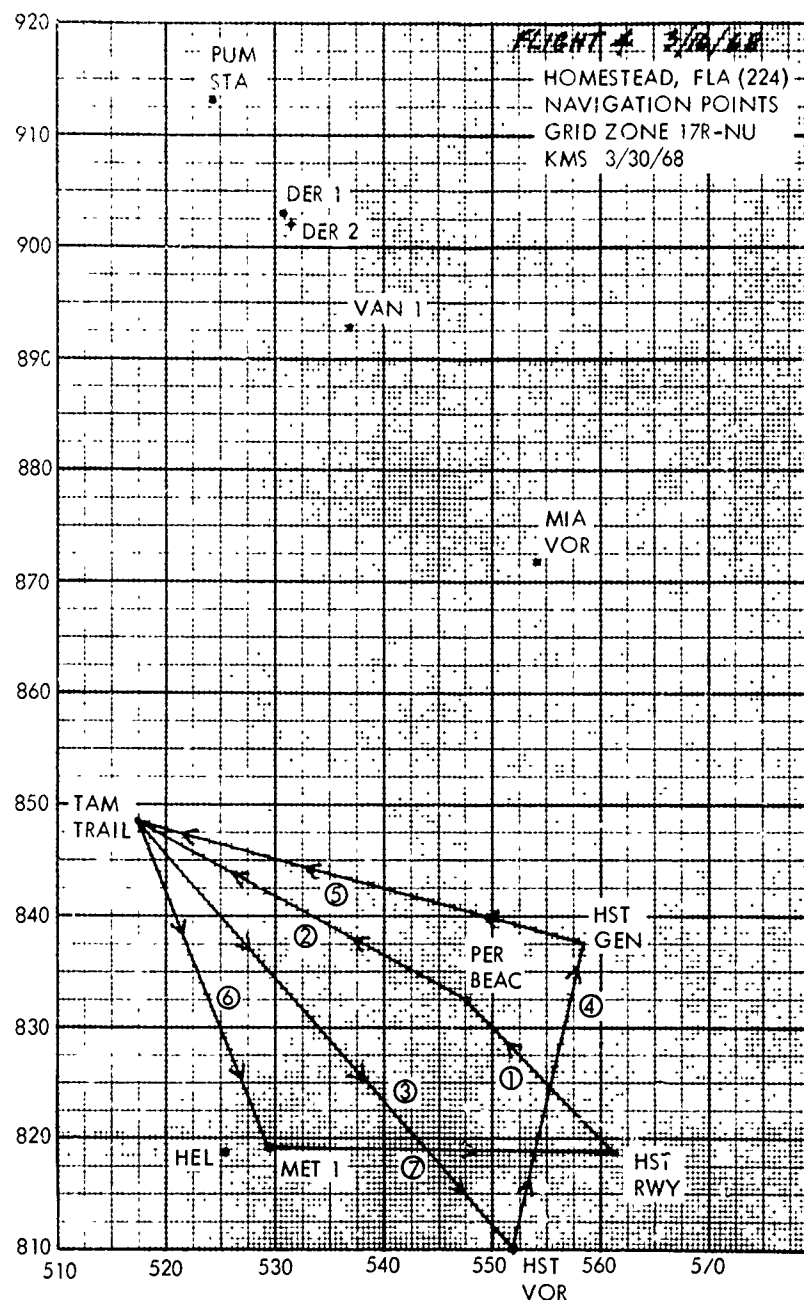
Figure 3-73. Flight 4—J0V1-B (27).

3.11.3.4 Flight 4/16 Mar 68 (Figure 3-73). Prior to flight 4, a preflight checkout indicated that the wind solutions were erratic. A broken wire was found in a connector leading to the side slip sensor output.

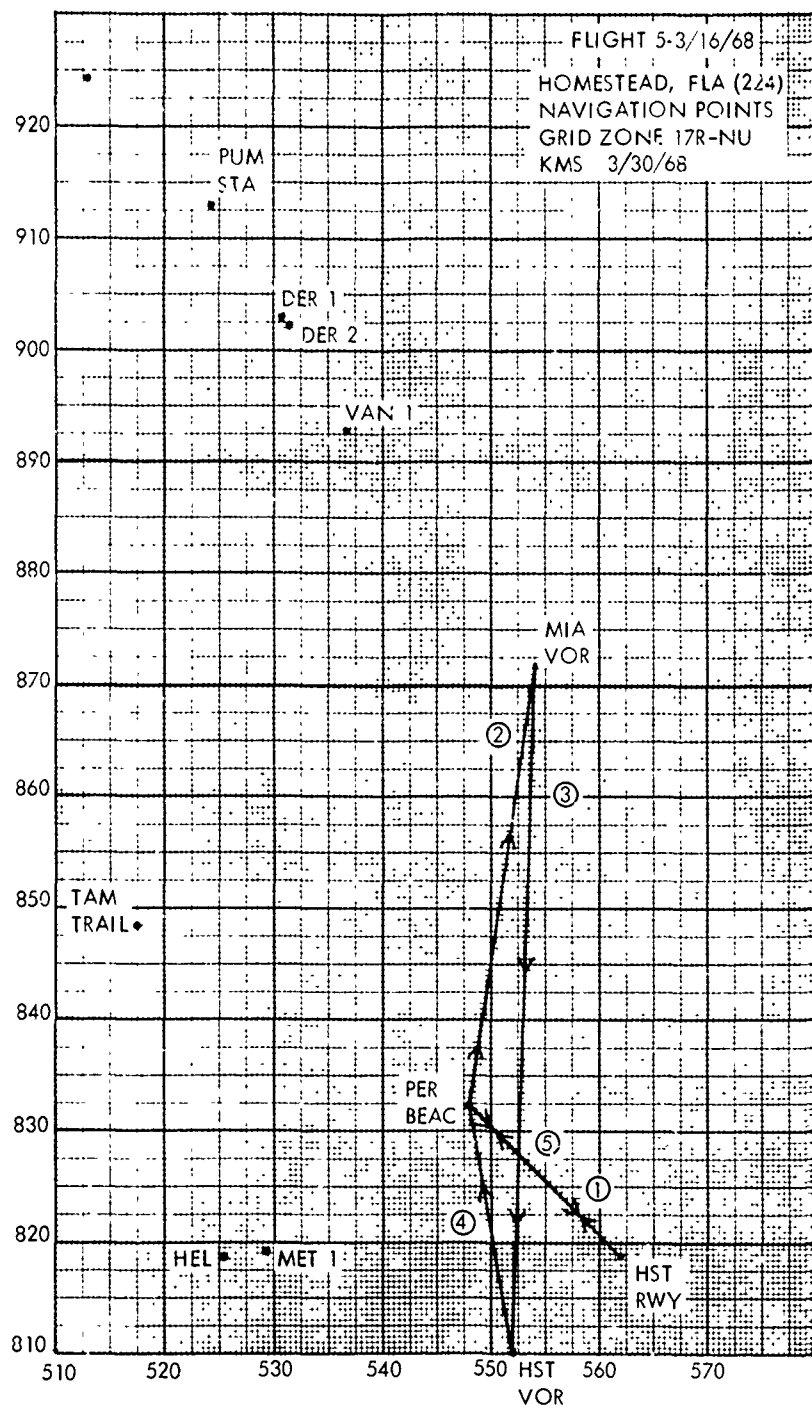
Figure 3-74. Flight 5-JOV1-B (27).

3.11.3.5 Flight 5 (See Map)/16 Mar 68 (Figure 3-74).

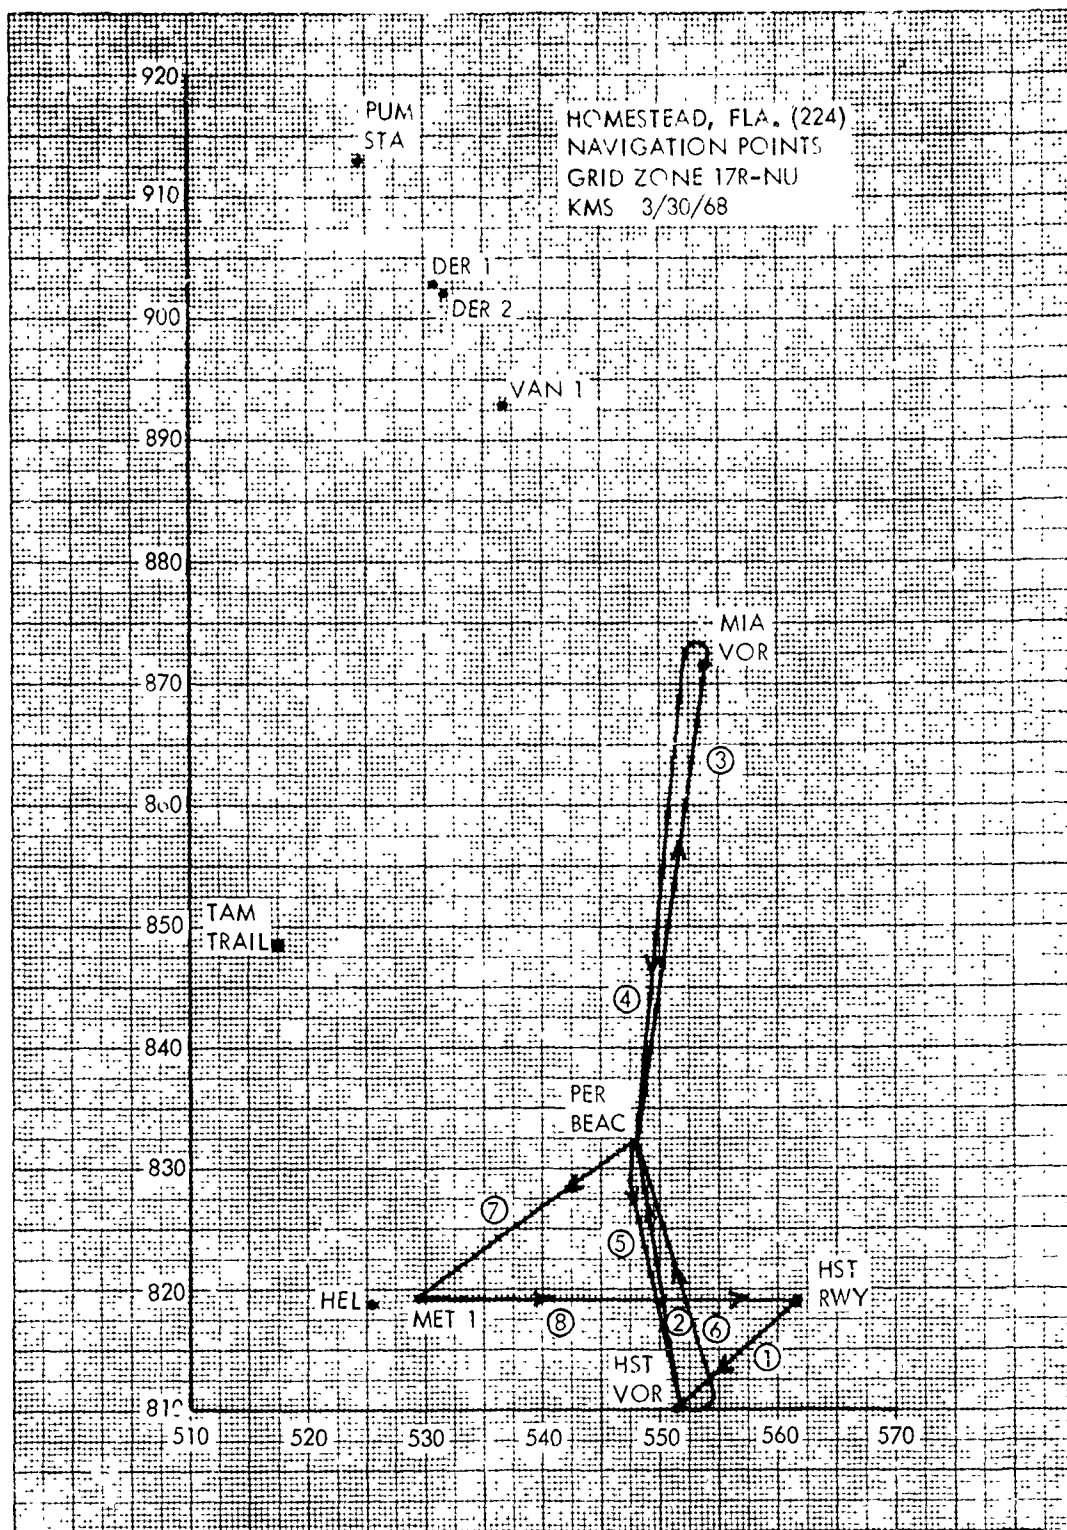
Figure 3-76. Flight 7-J0V1-B (27).

3. 11. 3. 7 Flight 7/19 Mar 68 (Figure 3-76).

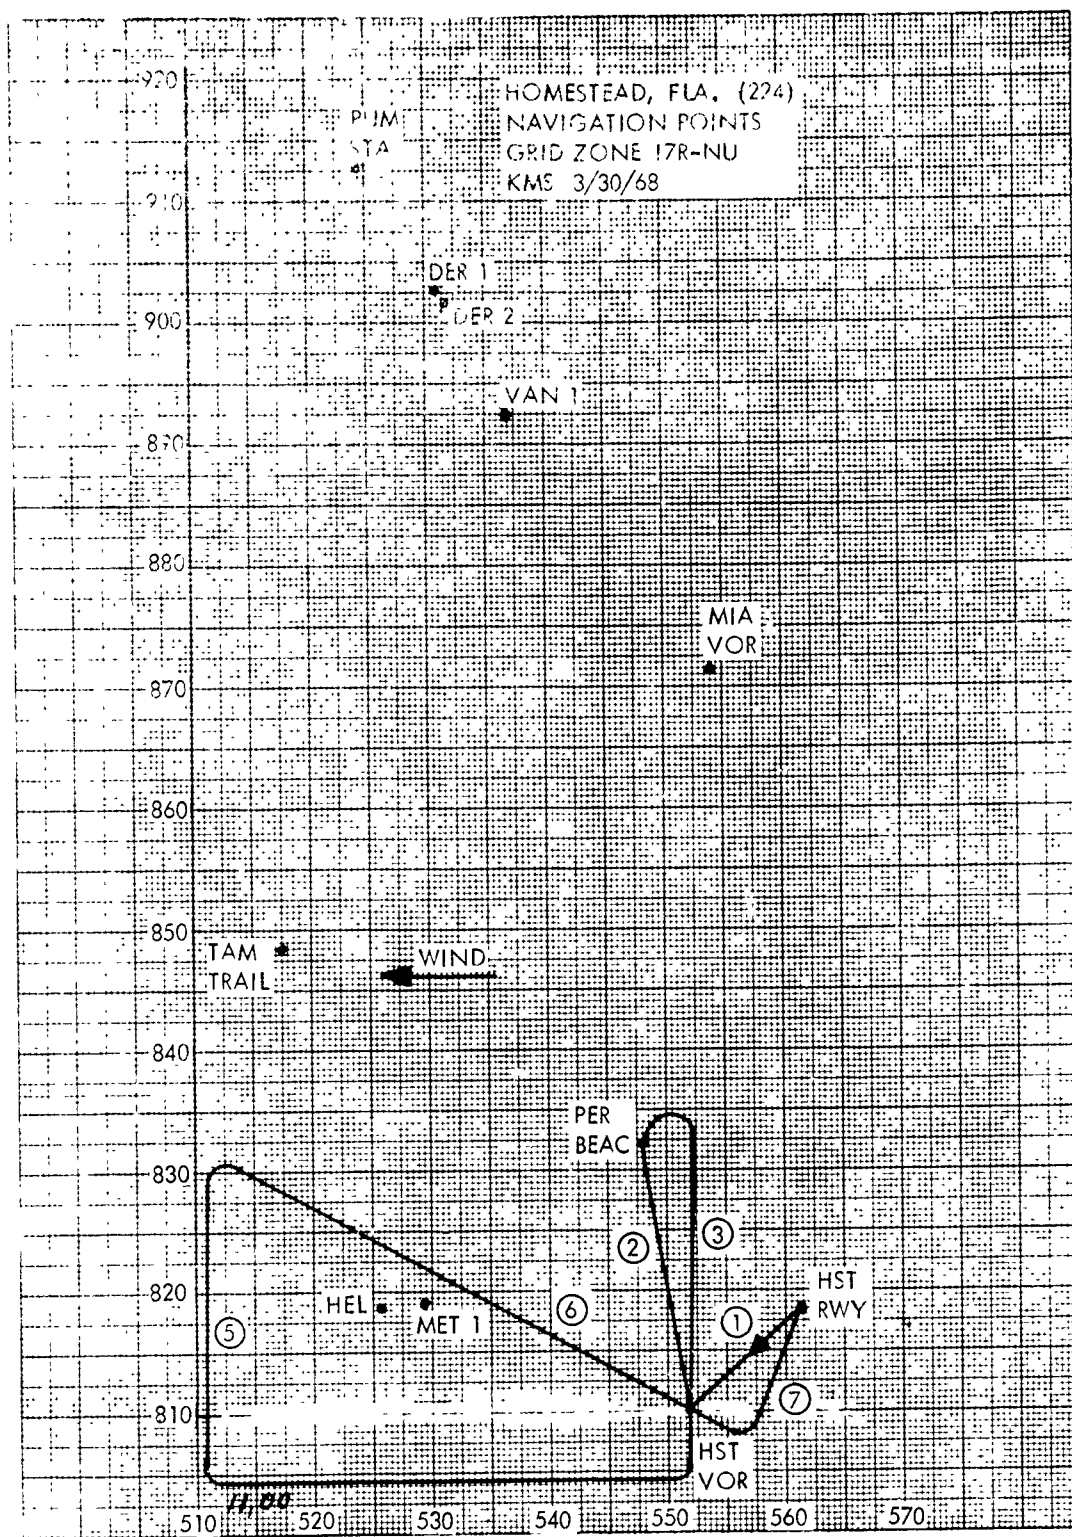
Figure 3-79. Flight 9-JOV1-B (27) Navigation Points.

3. 11. 3. 9 Flight 9/21 Mar 68 (Figures 3-79 and 3-80).
